Manhole Inspection Summary

Manhole # S25QQ1012MH

Location Address: **4709 ROLAND AVE**

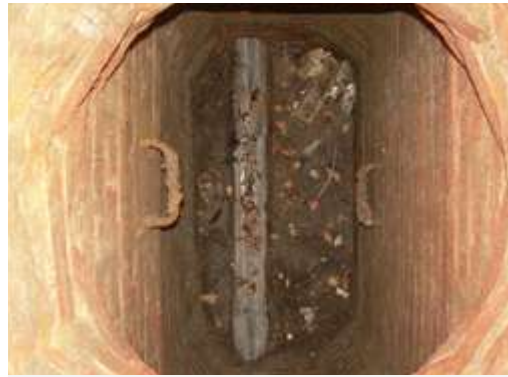
Top View

Corroded steps. Evidence of surcharge - Bench debris.

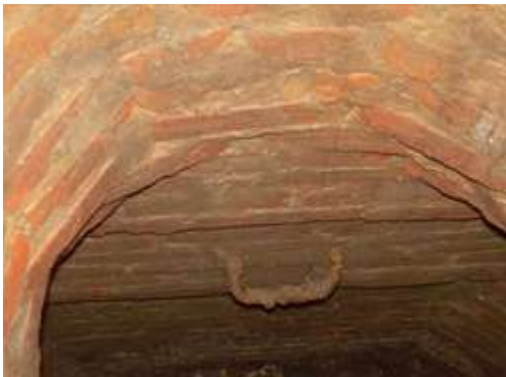
Defect

Adjustment, Corbel and Barrel infiltration.

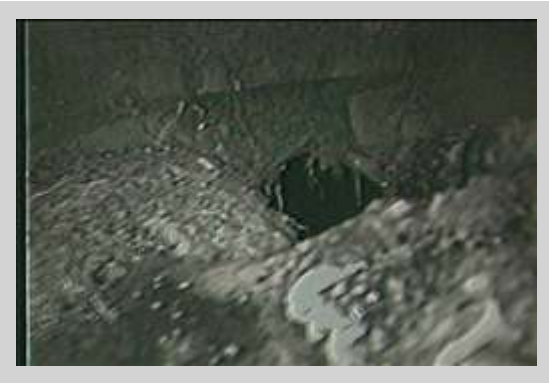
8 in. Circular Gravity Sewer Pipe Out @ 12 O'Clock

Bench and Channel debris.

Infiltration: **Evidence** Pipe Seal Cond: **Roots**

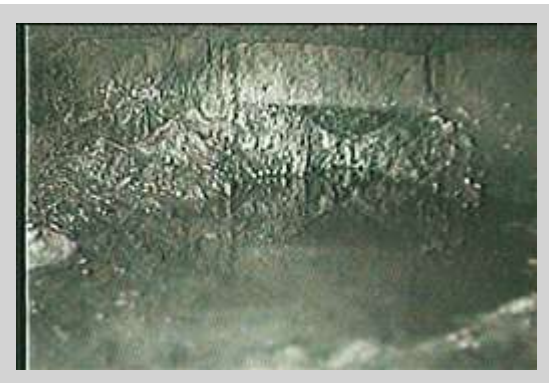
6 in. Circular Gravity Sewer Pipe In @ 6 O'Clock

Barrel deterioration and infiltration.
